Mexic-Arte Museum
Building Survey and
Feasibility Analysis

June 27, 2011

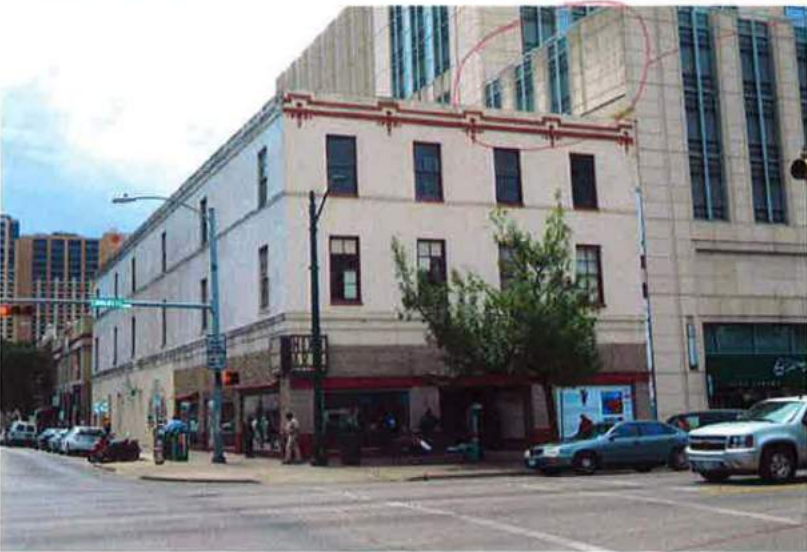
AIR SPACE / VIEW?

Photo 8
Mexic-Arte Museum's adjacency to
Frost Bank Tower

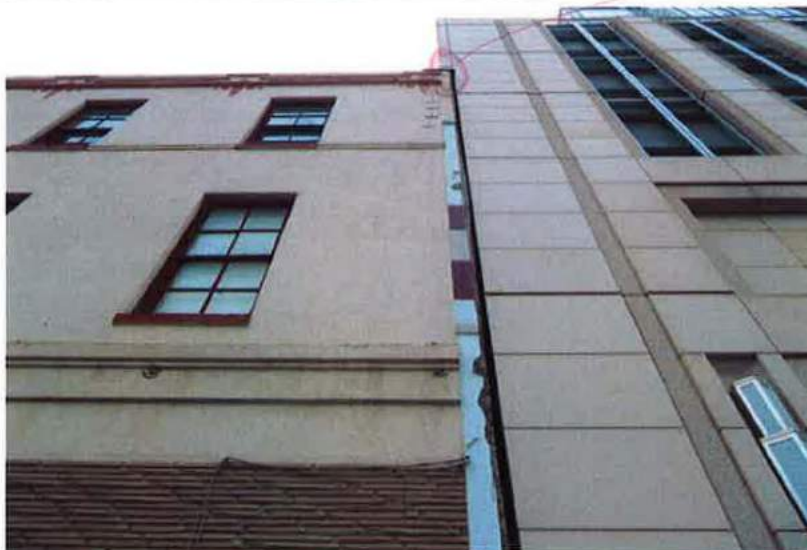
7. Existing structural issues – As noted in referenced structural engineering reports there are various structural considerations within the renovation approach including: unknown penetrations through the existing walls (Refer to Photos 9 and 10); the

WHO'S PROPERTY?

Photo 9
SW Corner of Mexic-Arte Museum,
adjacent to Frost Bank Tower

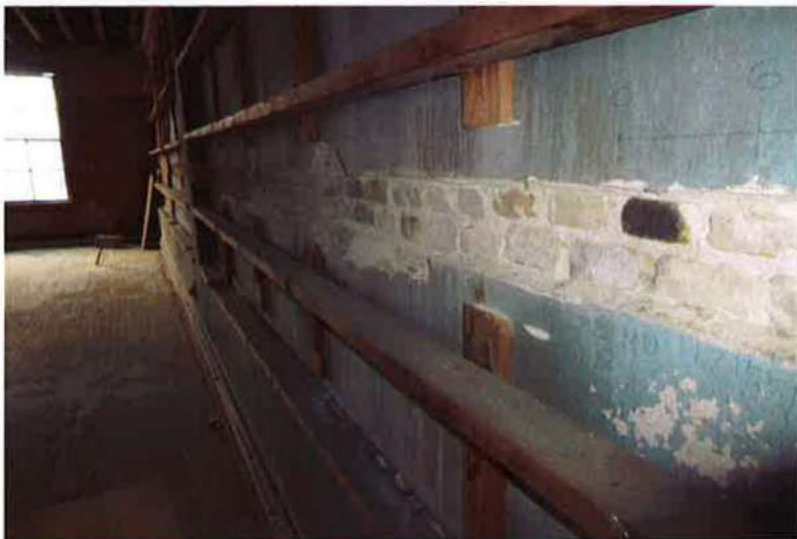
Photo 15
3rd Floor, North Wall Area
Ref: 1985 Report by Nyfeler
Organization

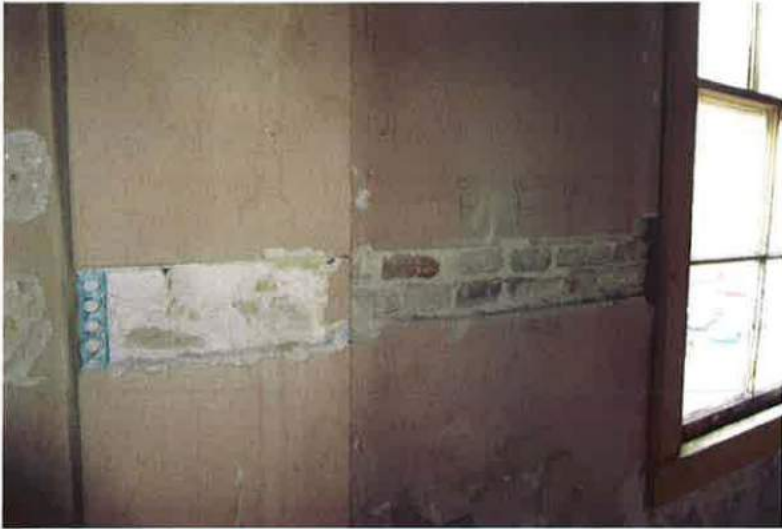
- ♦ Visual and destructive efforts to determine the extent of original 1860's construction. (Refer to 1985 Report by The Nyfeler Organization – summarized in *Exhibit 1.0 Documents Listing and Synopses* and depicted in Photos 16 and 17 of *Exhibit 10.0 Photographs and Location Plans*)

Photo 16
3rd Floor, North Wall Area
Ref: 1985 Report by Nyfeler
Organization

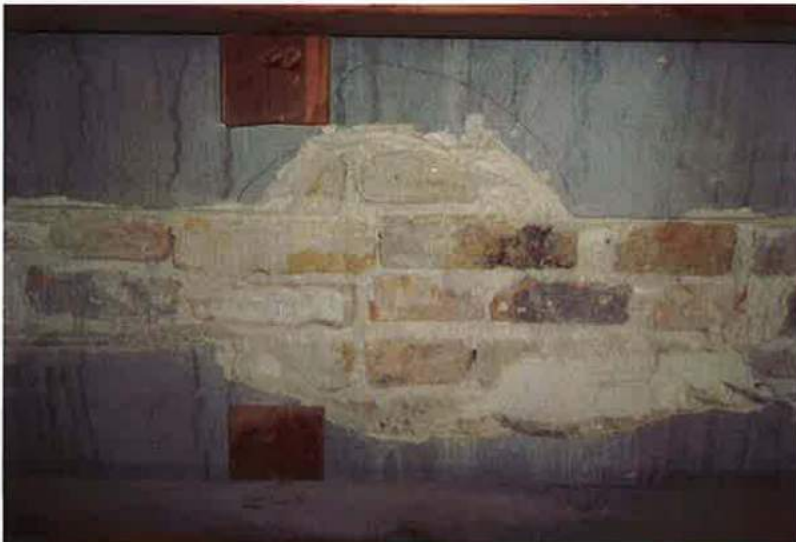
Photo 17
3rd Floor, North Wall Area
Ref: 1985 Report by Nyfeler
Organization

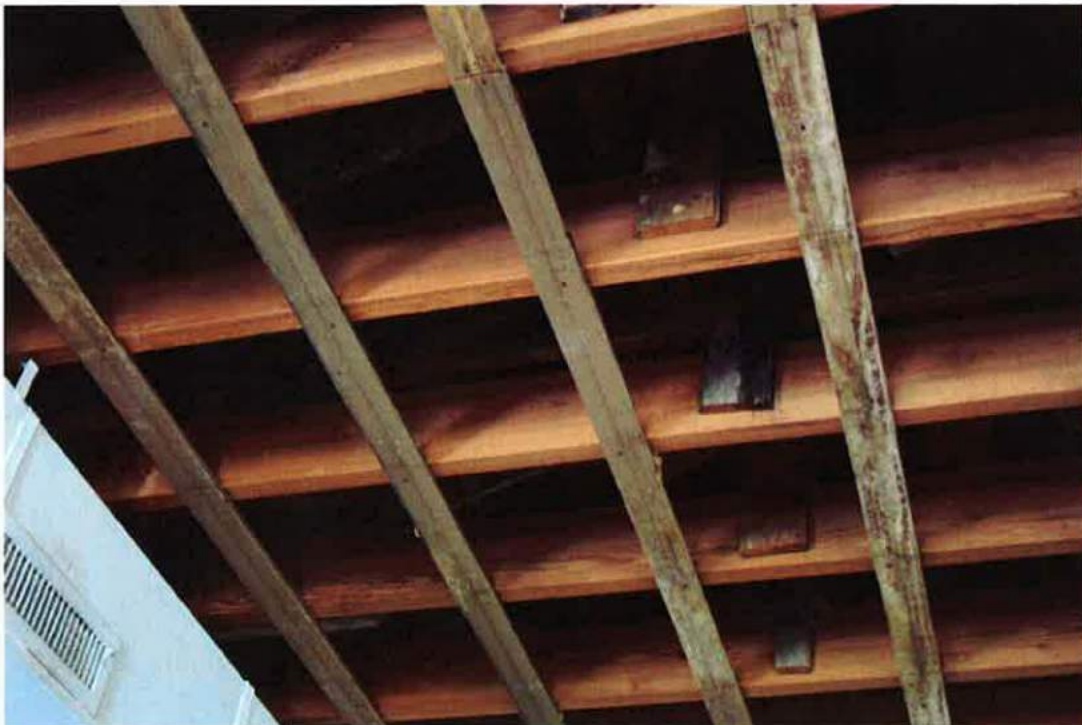
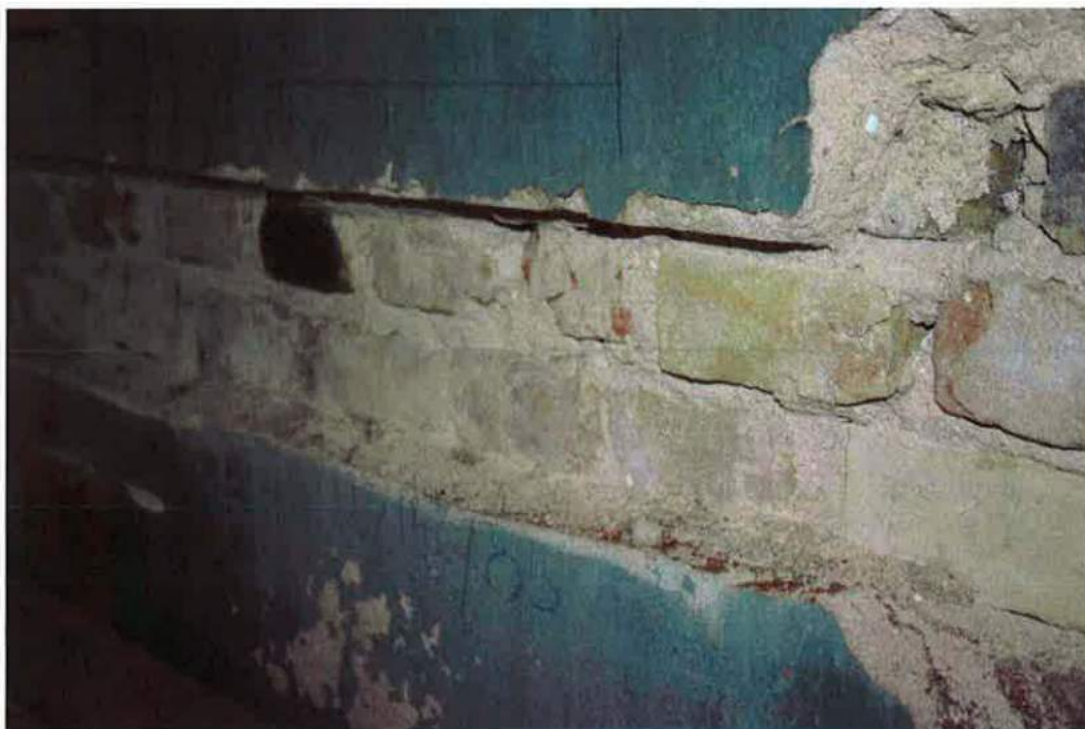
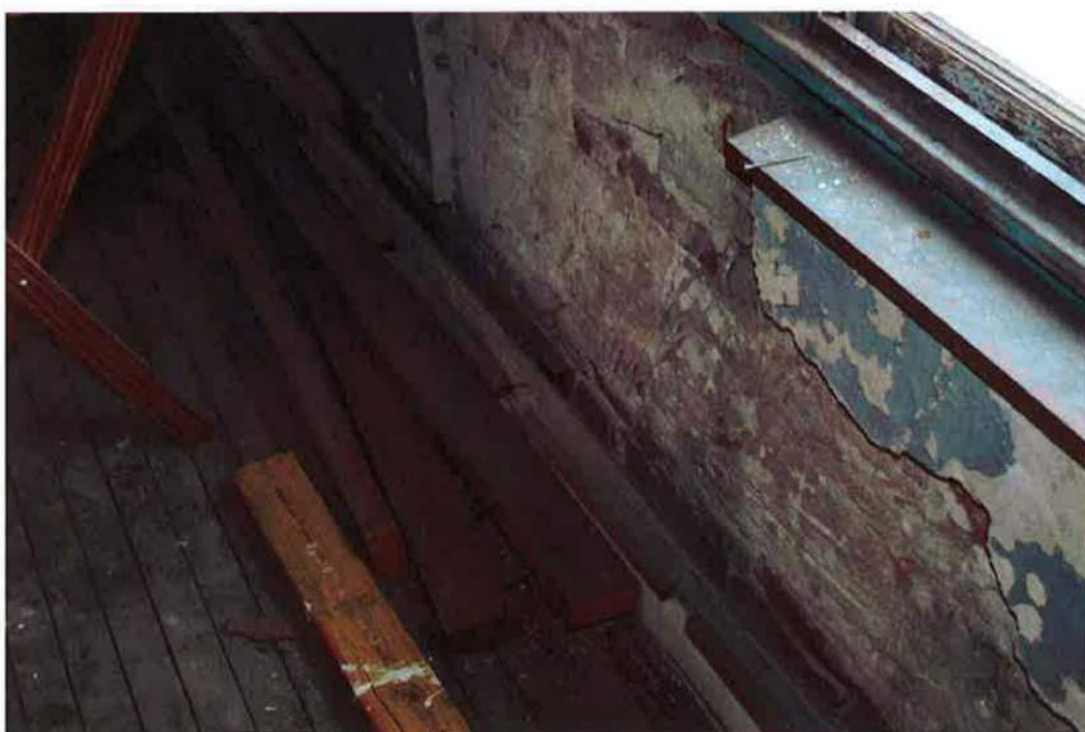
The present structure is primarily a three-sided façade held together with wooden struts and trusses. It has a common wall with the business next door. Though there is some brick and mortar construction, the top three floors are basically wooden pier and beam.

It is not clear if the building is completely sound as it is. A few years ago the roof blew off during a storm. Some steel cable was added across the roof to shore up the wall on the north side.
